Edison Electric
INSTITUTE

HECA Calibration Scenarios

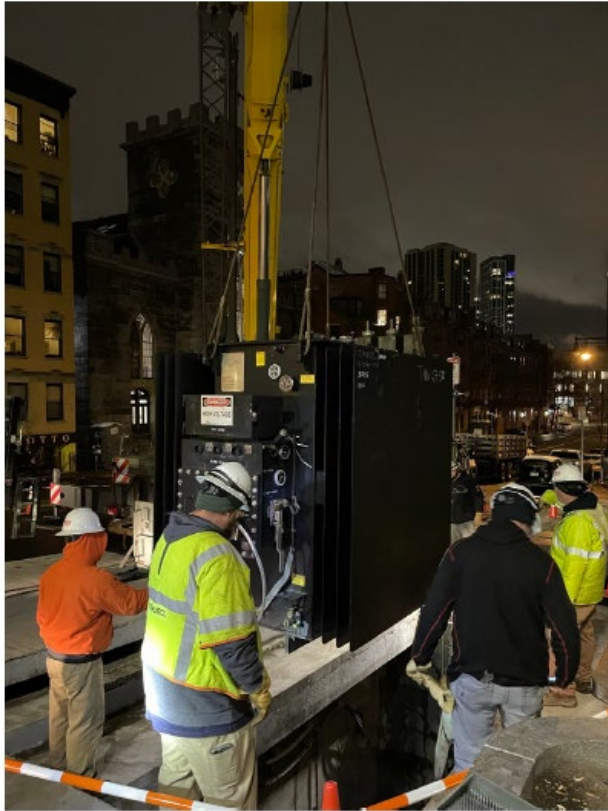
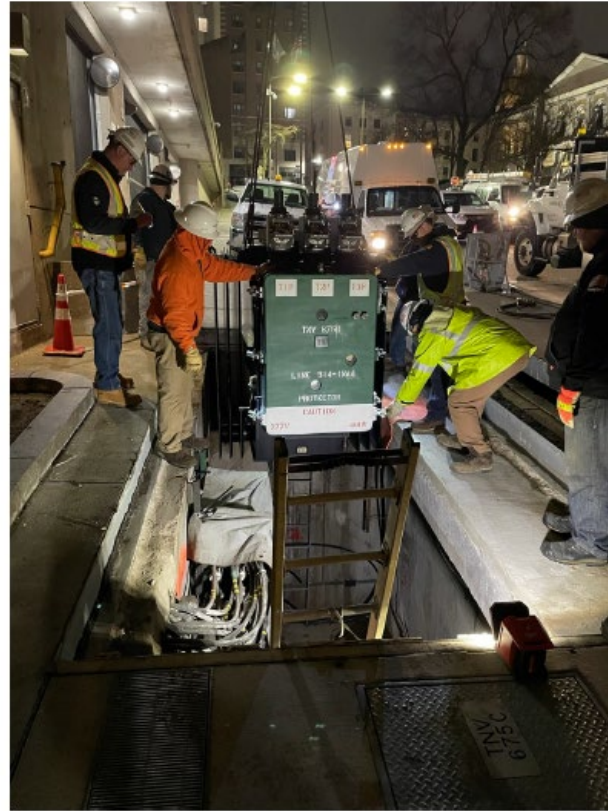
Photo 1

Network transformer being replaced into an 8 ft vault next to traffic. The traffic is blocked by machinery and work vehicles.

- Vault is de-energized
- 1 am, temperature 30F
- Machinery & work vehicles can handle the energy of traffic coming in.
- Transformer is rigged properly and used within limits
- The crane is not moving at the time of observation.
- Equipment has no mechanical issues.

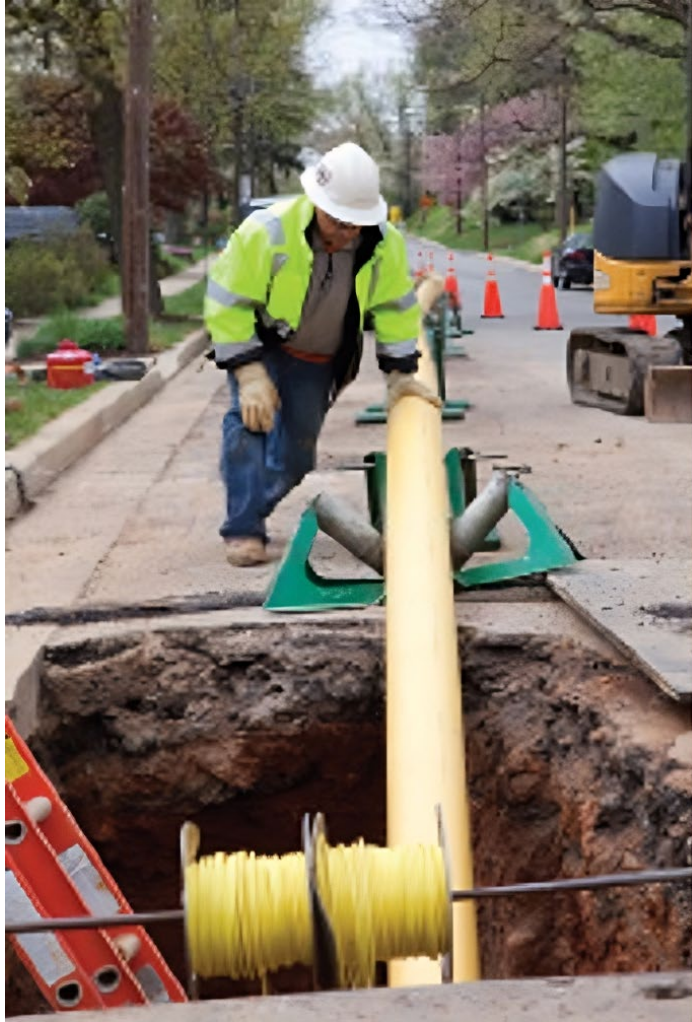
Photo 2

Feeding a pipeline underground next to a residential road.

- Hole is 6 ft deep
- Locates are completed
- No flagger or blockers
- Excavator is moving as work is performed
- Pipe is not moving
- Employee is in the hole and has a gas monitor
- Excavation lacks other utilities (gas, electric, steam)

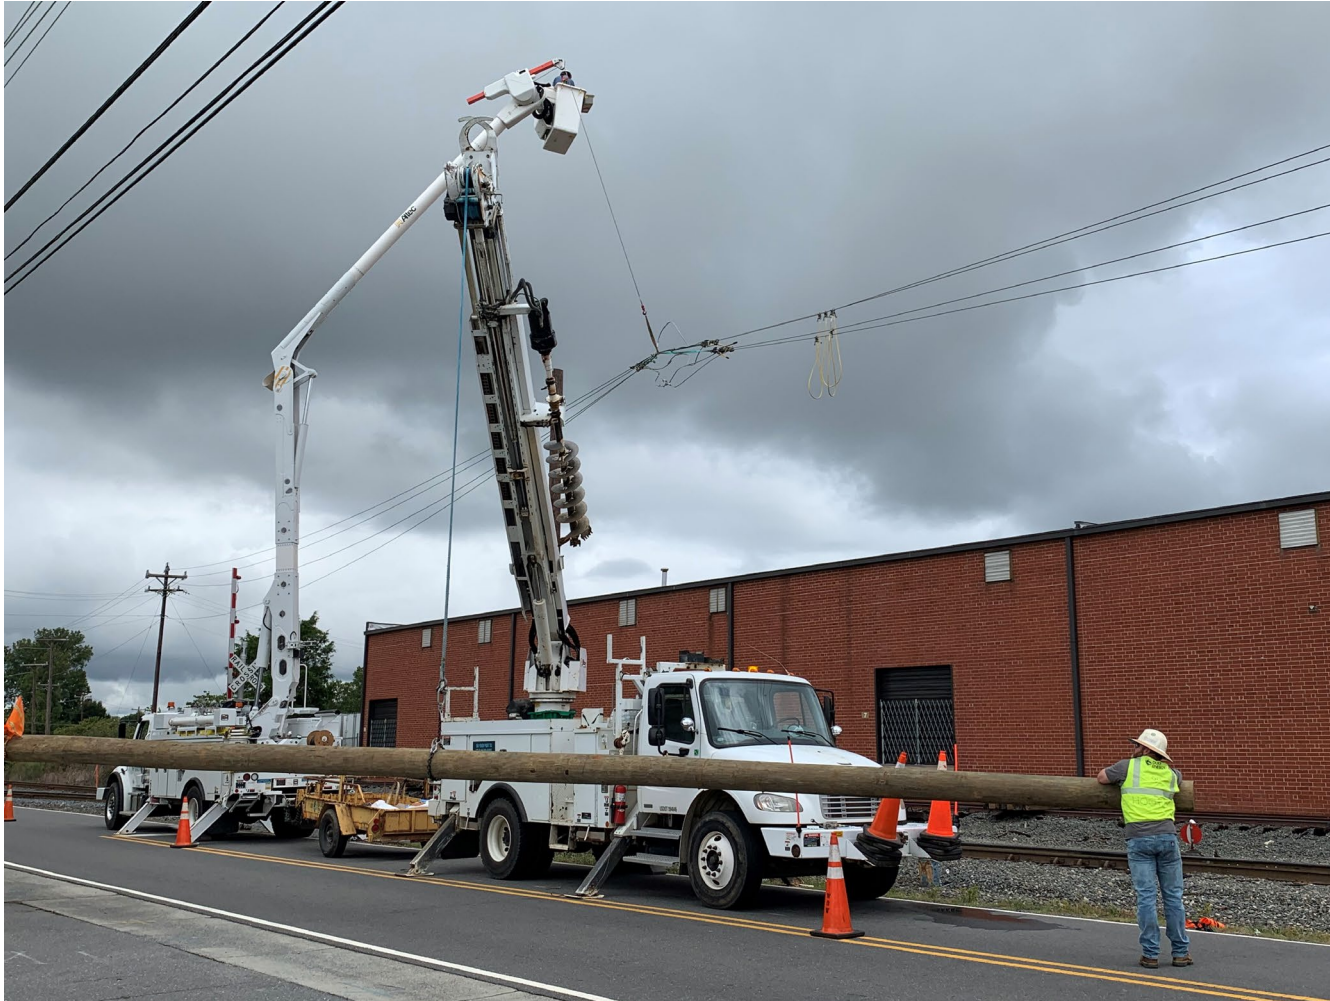
Photo 3

Pole setting on de-energized lines in a high traffic industrial area.

- Lines are properly tested and grounded.
- Rigging properly installed and inspected by the foreman.
- Fall protection system inspected and worn properly .
- Tension in the lifting cable is not calculated.
- Equipment was stationery at the time of observation and has no mechanical issues.
- The bucket trucks were set up properly and stabilized.

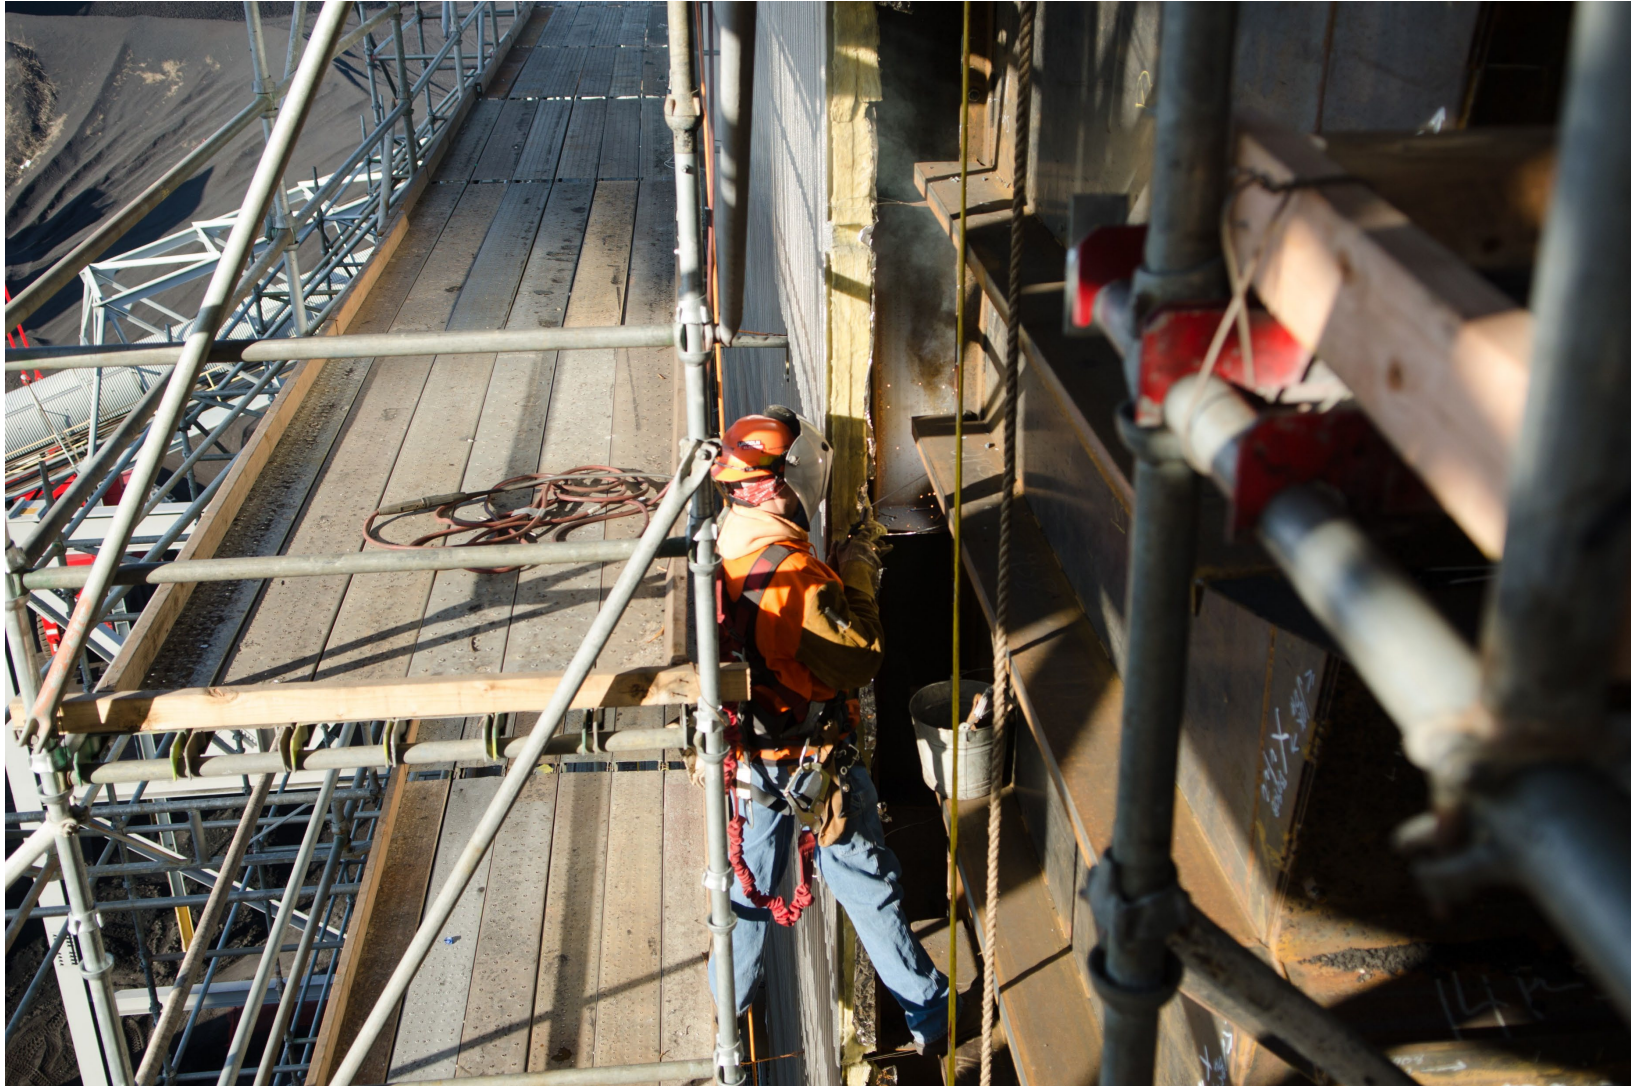
Photo 4

Welding at 23 feet.

- No one is working above or below (exclude form analysis).
- Gas welding
- The fall arrest is not properly tied off.
- The employee has proper gloves .

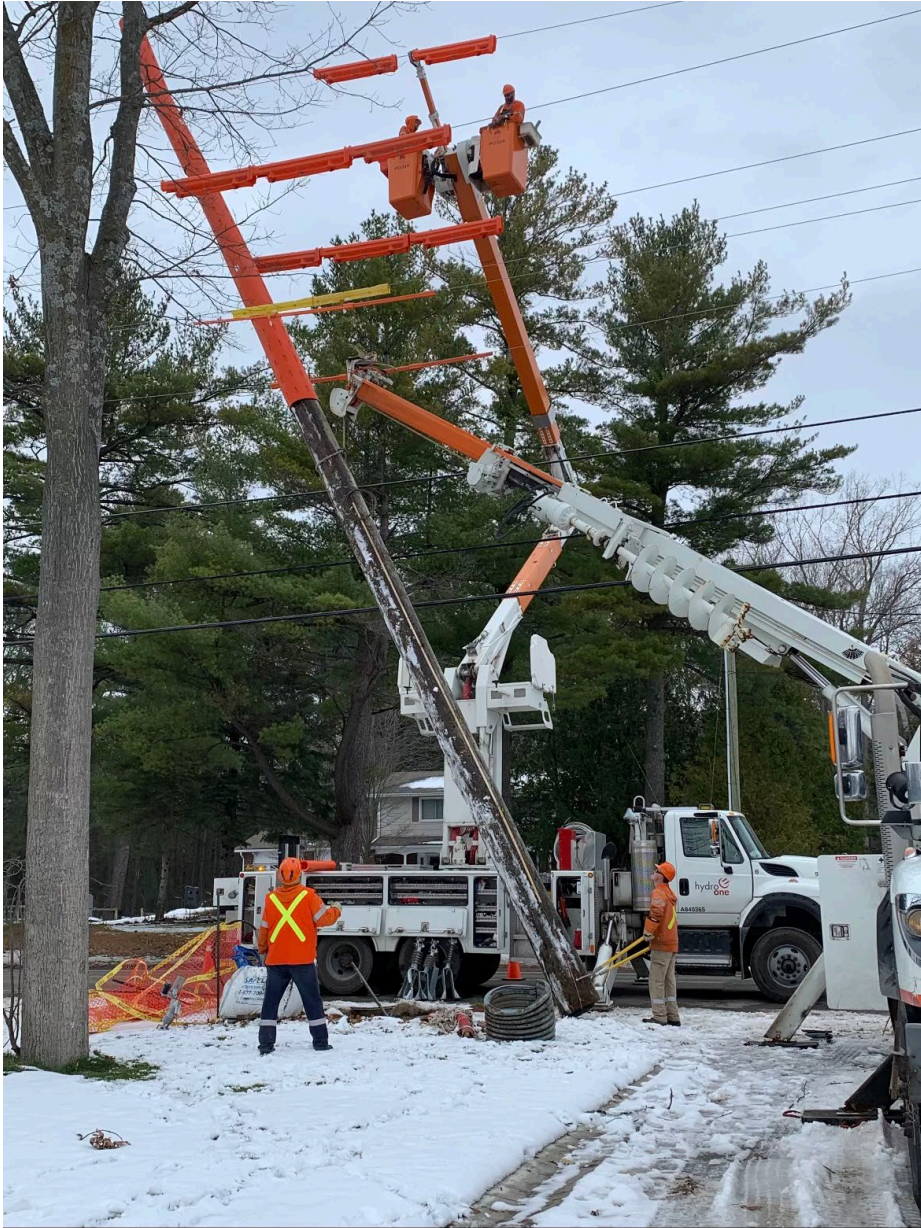
Photo 5

A double circuit, live line pole set next to industrial road. The hole has been prepared for installation.

- Equipment has no mechanical issues and is maintained properly.
- The bucket trucks were set up properly and stabilized.
- There is no swinging control on the load (sling job rather than claw on digger)
- Proper fall protection is used.
- Cover on all conductors, live line insulation is sufficient.
- Proper PPE for electrical contact is used.
- The roadway is closed to traffic with hard barricades.
- Equipment was moving at the time of observation.

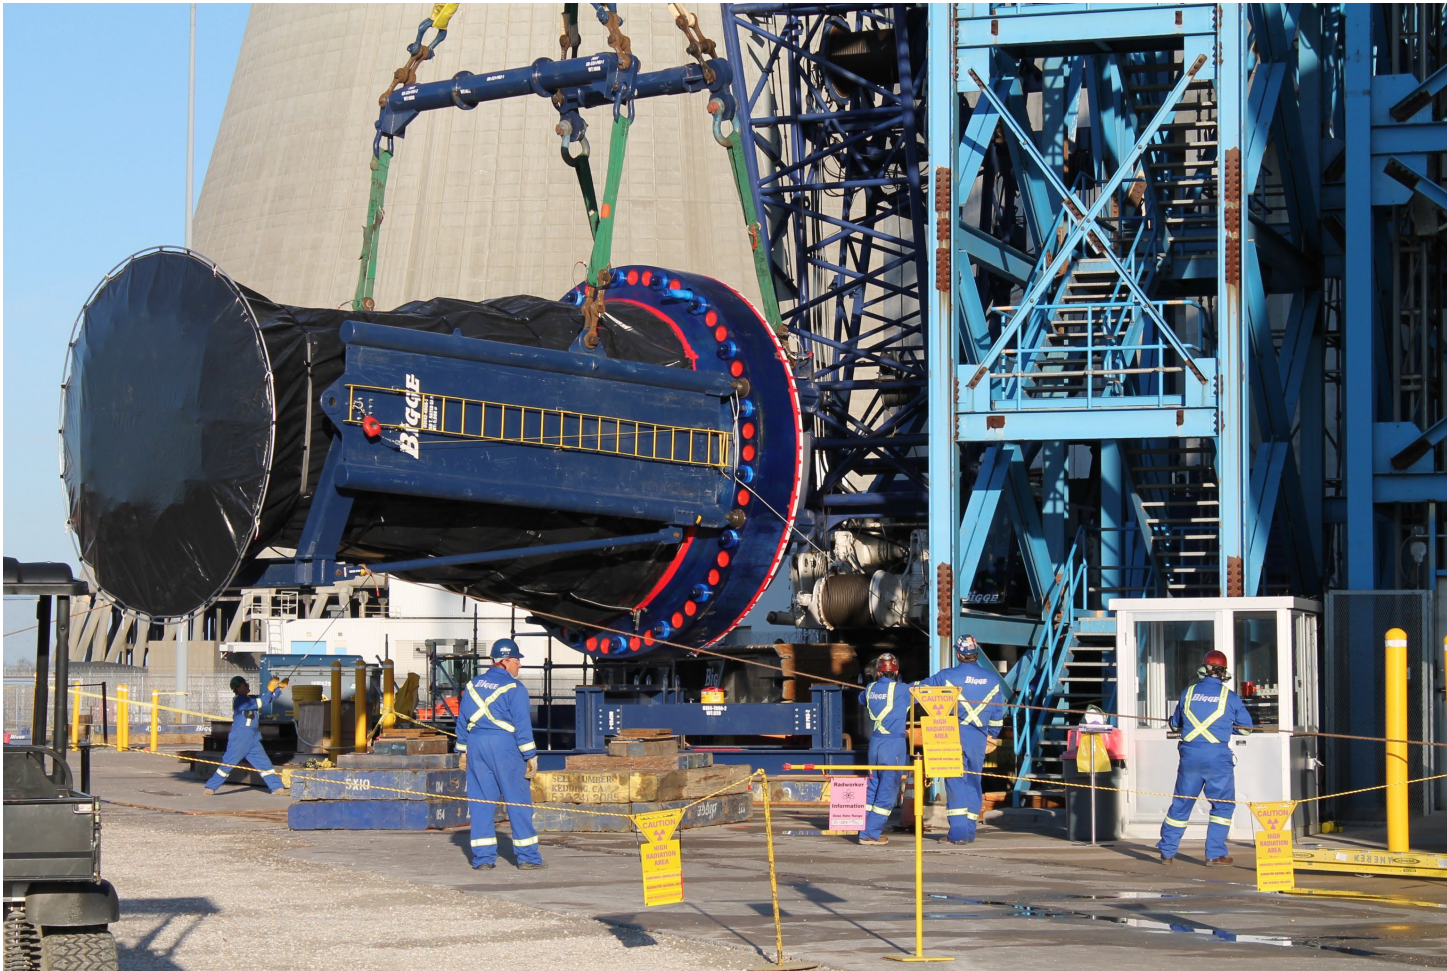
Photo 6

Vessel being lifted.

Vessel is 77 tons and 48 ft. long.

Drop zone is marked and tag lines being used to control the lift.

- Crane is a tower crane.
- Operating work vehicle parked on site road.
- Caution signs state high radiation area risk. All workers wear dosimetry, no active radiation present during observation period.
- Equipment has no mechanical issues.
